AIRCRAFT ACCIDENT INVESTIGATION REPORT

Japan Air Lines Co., Ltd.
Boeing 747 SR-100, JA8119
Gunma Prefecture, Japan
August 12, 1985

Aircraft Accident Investigation Commission
Ministry of Transport

June 19, 1987

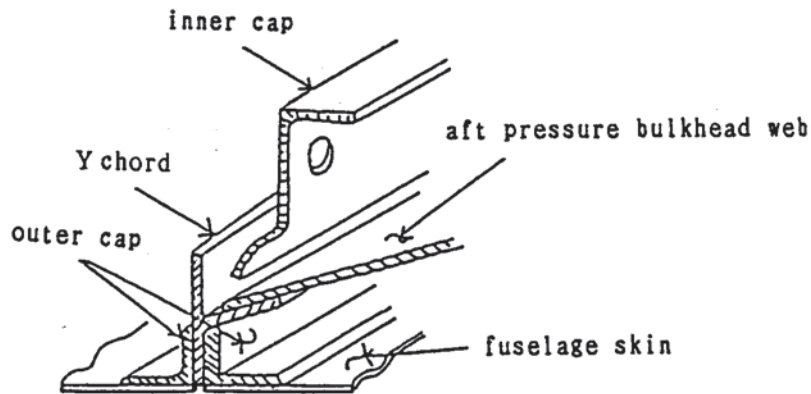
Figure-1 Cross Section of Joint of Y Chord and Fuselage

(3) In BS2360, the ringform chord of a Y-section (hereinafter referred to as "Y" chord, see Figure-1) retained on the whole its original circular form, although partly bent.

(4) A major part of the inner cap (a ringform angle of L-section having lightening holes) attached inside of, and along the Y chord was fractured and separated from the Y chord, and the rivets connecting the inner cap with Y chord were sheared off by forces at right angles to their shanks.

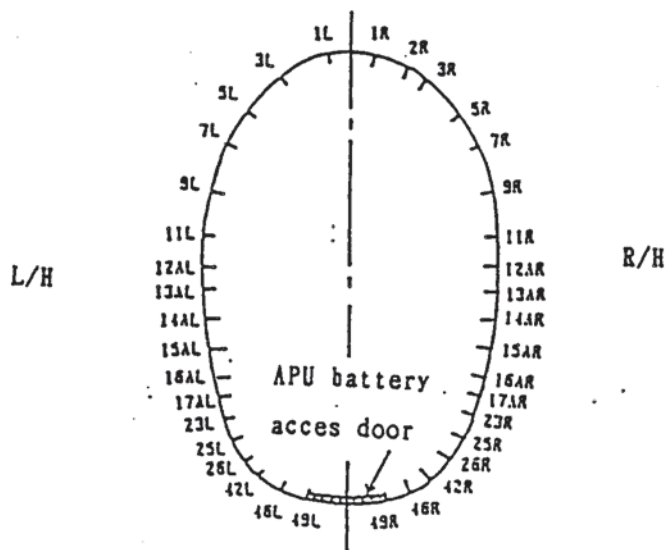
Figure-2 Cross Section of BS2658 where APU Fire Wall is attached (as viewed from the rear)

(5) Fractures along the circumference of BS2658 (where APU fire wall is attached) were as follows:

(a) Between fuselage stringer 1L (hereinafter stringers are represented by abbreviation only, where L indicates left side, and R right side) and 1R, the forward angle, doubler, and forward fuselage skin were all fractured on fastener row ① (see Photo-33).

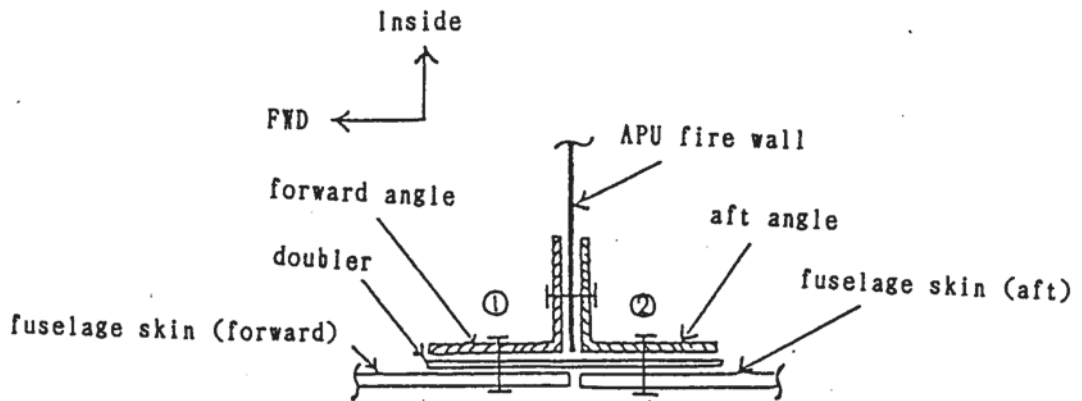
Figure-3 Cross Section of Joint of APU Fire Wall and Fuselage

(c) The portion Near 9R remained, the cross section shown in Figure-3 being kept unchanged. From 11R through 15AR a fracture was found on fastener row ②, only the doubler remaining in the rear. The doubler was fractured on fastener row ② by tension (see Photo-35).

(d) In the vicinity of 15AR there was a slight portion where the forward angle, doubler and forward fuselage skin were all fractured on fastener row ①, but from there to 23R the cross section as shown in Figure-3 was kept unchanged, and fragments of the APU fire wall, although few, were remaining.

(g) From the middle of 4L and 5L to 7L, the cross section as shown in Figure -3 was unchanged and part of APU fire wall was remaining.

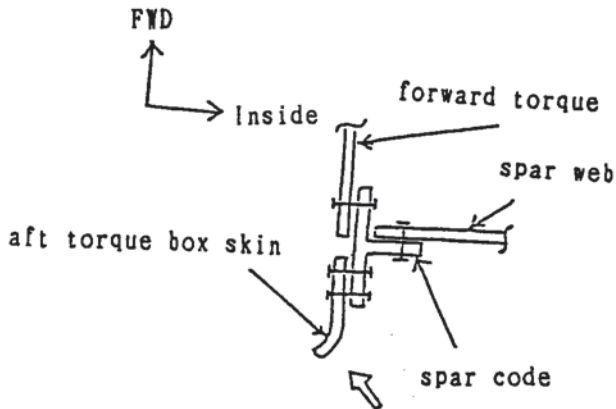
(b) In most part of the left side front spar chord of the forward torque box above FS395, the skin of the vertical fin's aft torque box was fractured immediately aft of the spar chord, leaving some skin on the spar chord side. The skin which remained on the spar chord side was bent outward (see Figure-4a and the arrow in Photo-44). Above the vicinity of FS545, there was part where the head of rivets connecting the aft torque box skin and the spar chord was broken o.f by a force applied in its shank direction, and the skin was separated (see Figure-4b and the arrow in Photo-45).

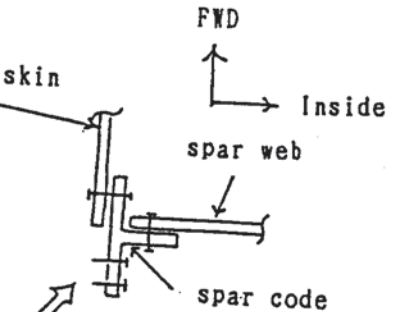
Figure-4b

(c) The right side front spar chord of the forward torque box above FS395 was fractured for almost half of its entire length in the same state as shown in Figure-4b(see the arrow in Photo-46). A very small number of rivets near FS 545 were found sheared off by force at right angle to their shanks (see Figure -4c and the arrow in Photo-47). Near FS495, the aft torque box's skin was

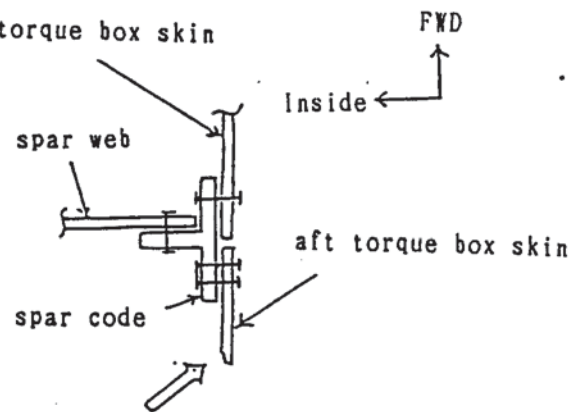
torn off and fractured, and there were parts where fragments remained connected to the spar chord (see Figure-4d and an arrow in Photo-48).

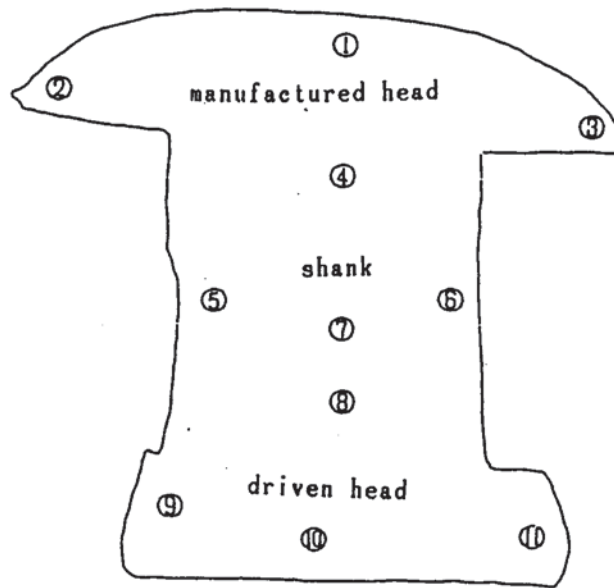
Figure-5 Hardness Distribution of L18 Stiffener in No.29 Rivet
BACR15BB-D Aluminum Alloy 2017-T3

Measured Points	Micro Vickers Hardness
	HV(500g)
①	144
②	134
③	142
④	154
⑤	137
⑥	156
⑦	149
⑧	154
⑨	166
⑩	179
⑪	170

Based on the results of the testing including the chemical analysis, microstructure inspection, and mechanical properties test above, it is verified that qualities of the structural materials used in the aft pressure bulkhead met specifications for materials of the aircraft manufacturer, and materials standards.

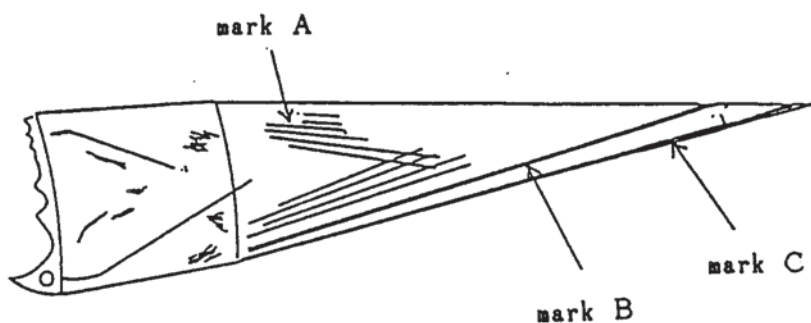
Figure-9 Stripped Contact Marks on Upper Surface of Lower Rudder

2.16.3.5 Marks "B" and "C" in Figure-9 are estimated to be marks caused by adhesion of the gum seal installed under the surface of the upper rudder strongly compressed between the two rudders. Such severe compression to the gum seal does not occur during operation. The adhesion may therefore be estimated to have resulted from severe compression applied to the gum seal by the upper rudder when it was torn off. It was, however, impossible to clarify the process by which marks B and C were caused, because a little was recovered of the wreckage of the rudder.

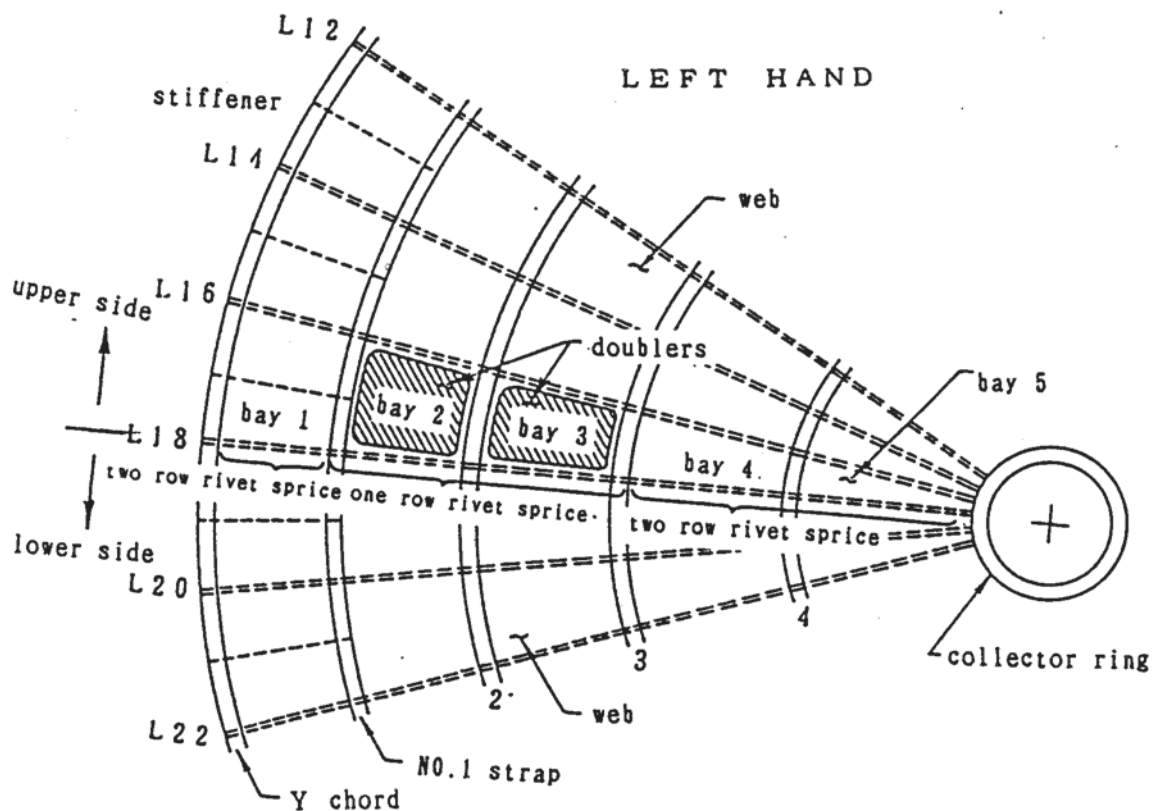
Figure-12 Vicinity of L18 Splice of the Aft Pressure Bulkhead

(2) The doublers applied to bay 2 and bay 3 of the accident aircraft as shown in Figure-12 have little effect on the stress distribution along L18 splice, and therefore have little effect on the propagation of fatigue cracks.

When L18 splice is broken into two portions, upper and lower, the stress of bay 5 connected with a collector ring increase. This indicates a possibility that the connection of the web and the ring is then ruptured towards a series of succeeding ruptures.

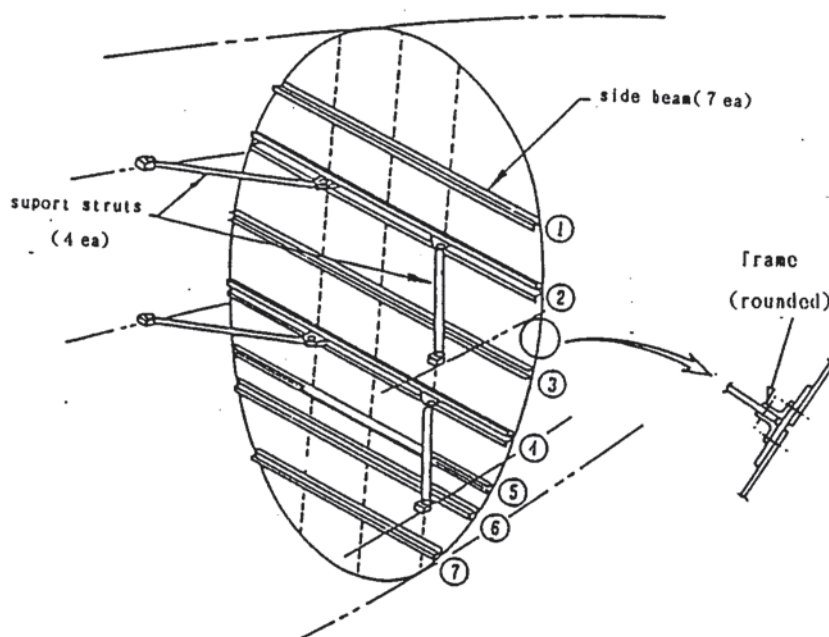
Figure-14 Outline of APU Firewall Structure .

(5) The time required for the pressure to the APU firewall to reach about 4 psi is estimated to be extremely short, and therefore the rupture would have been momentary and impulsive. However, the actual process of destruction would have been more complicated than that estimated in the above calculation which based on static analysis.

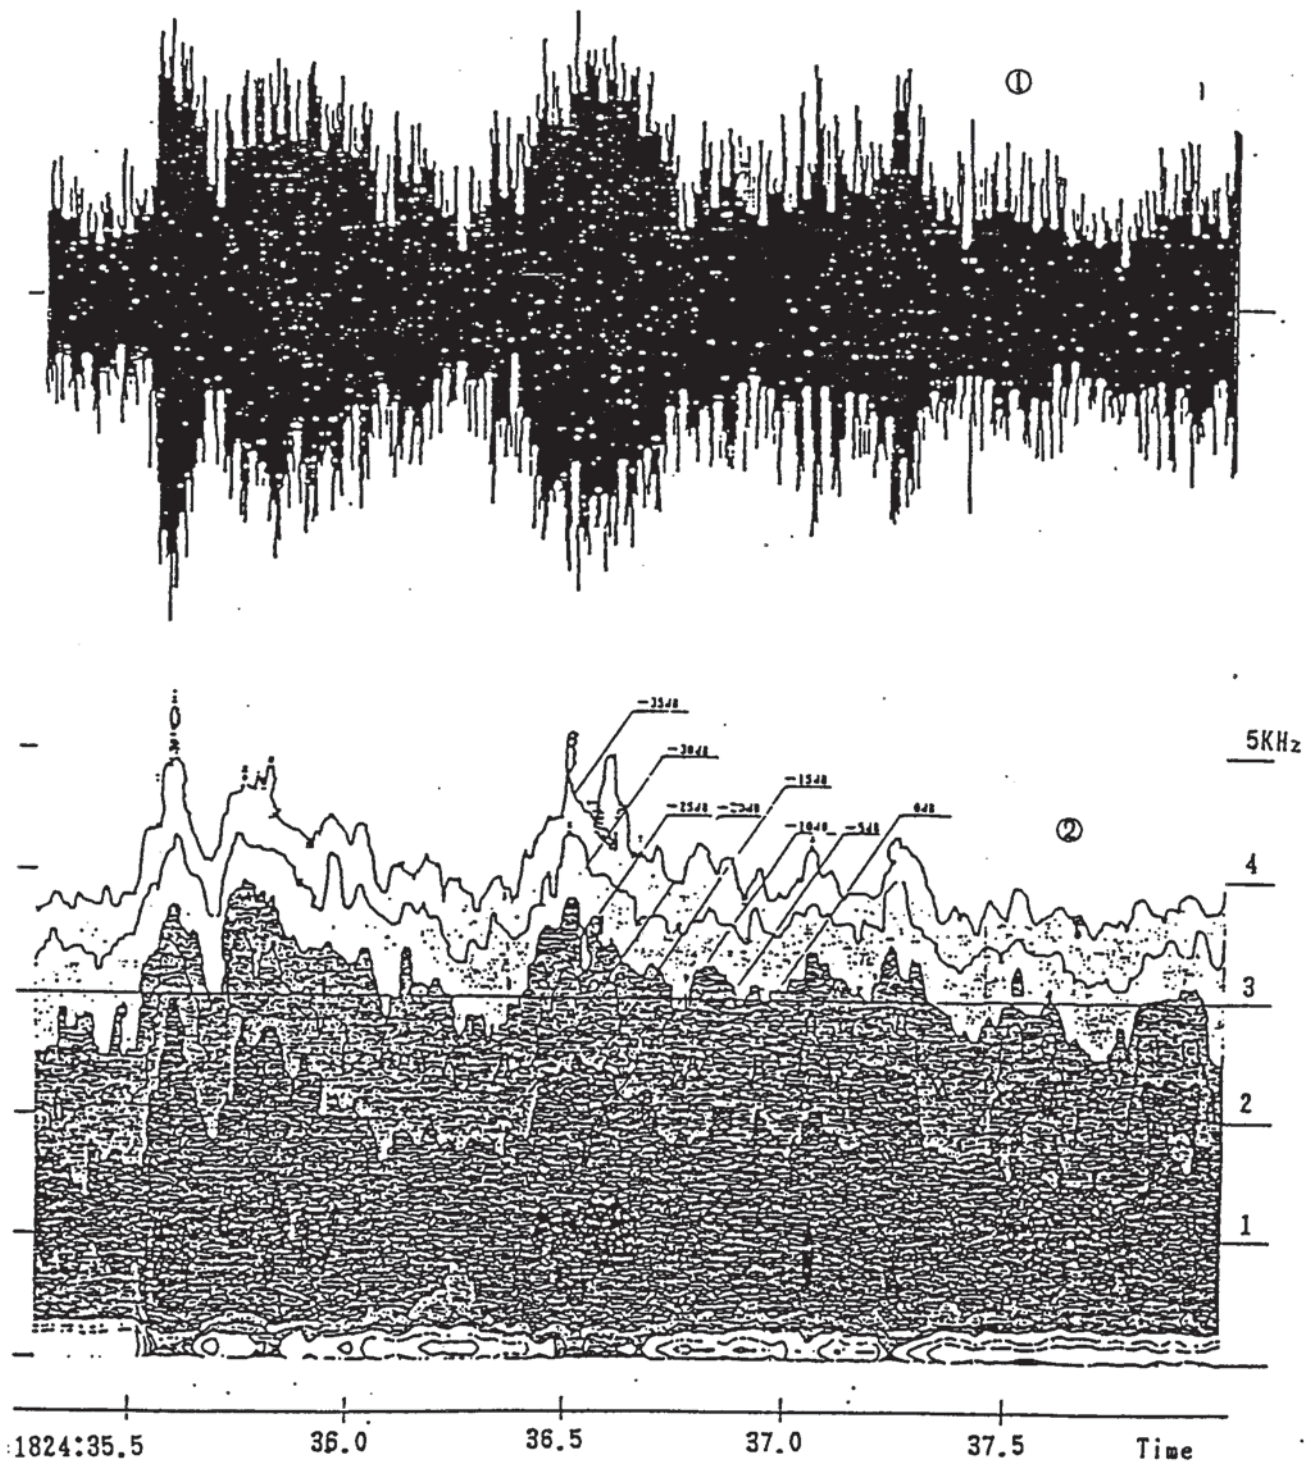
Figure-16 CVR Playback Wave and its Sound Spectrogram
CVR Playback Wave ① and its Sound Spectrogram ②

A sound like "bang" was heard from 1824:35.5-35.6 to 1824:37.0. The frequency analysis made on playback signals of CVR around this period indicated that the sound was composed of several groups. The played-back wave of CVR and its sound spectrogram are shown in Figure-16.

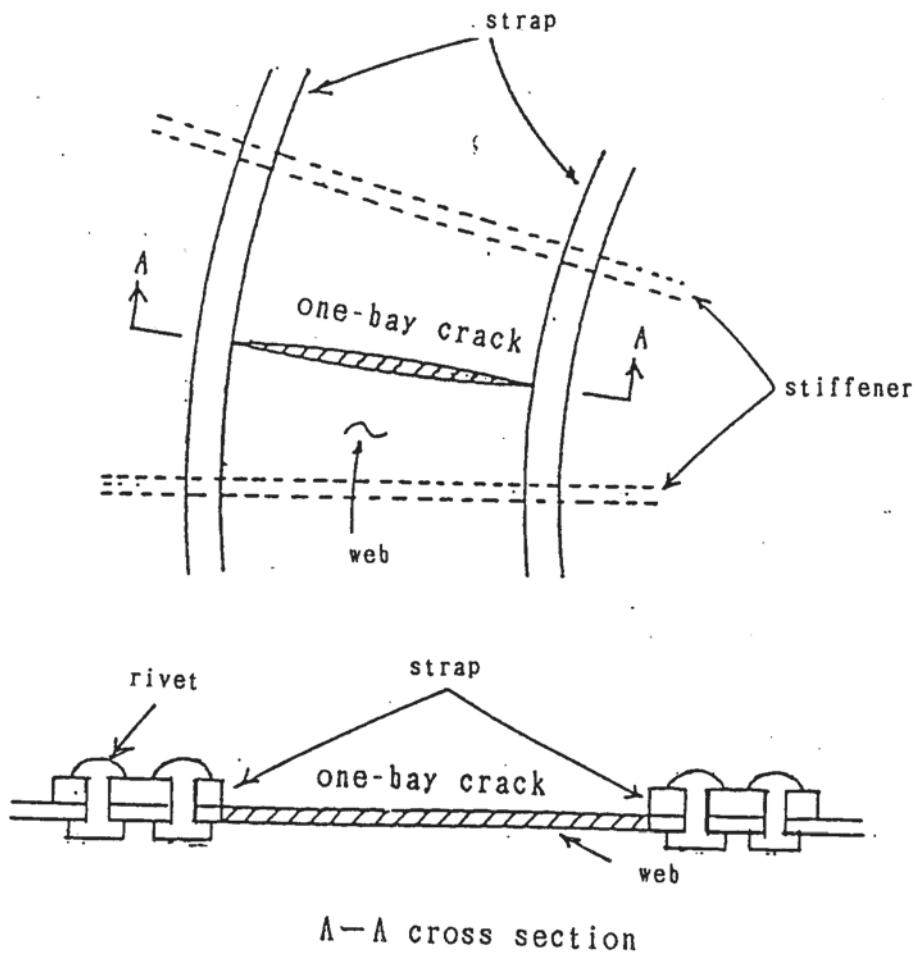
Figure-18 Failsafe Analysis of the Aft Pressure Bulkhead

In the design of the bulkhead of the aircraft, the residual strength is verified analytically with the condition that the bulkhead with one-bay crack shown in Figure-18 can withstand the expected maximum cabin pressure differential (the maximum operating pressure of the over pressure relief valve: 9.4 psi) considered as the fail-safe load.

It is conceivable that the premise of the one-bay fail-safe, that is, a crack was detected and repaired while it was staying within one bay, collapsed for the reasons that it was difficult to detect the fatigue cracks of the accident aircraft by visual inspection or by air leakage because the cracks were small and propagated along rivet holes at web overlaps.

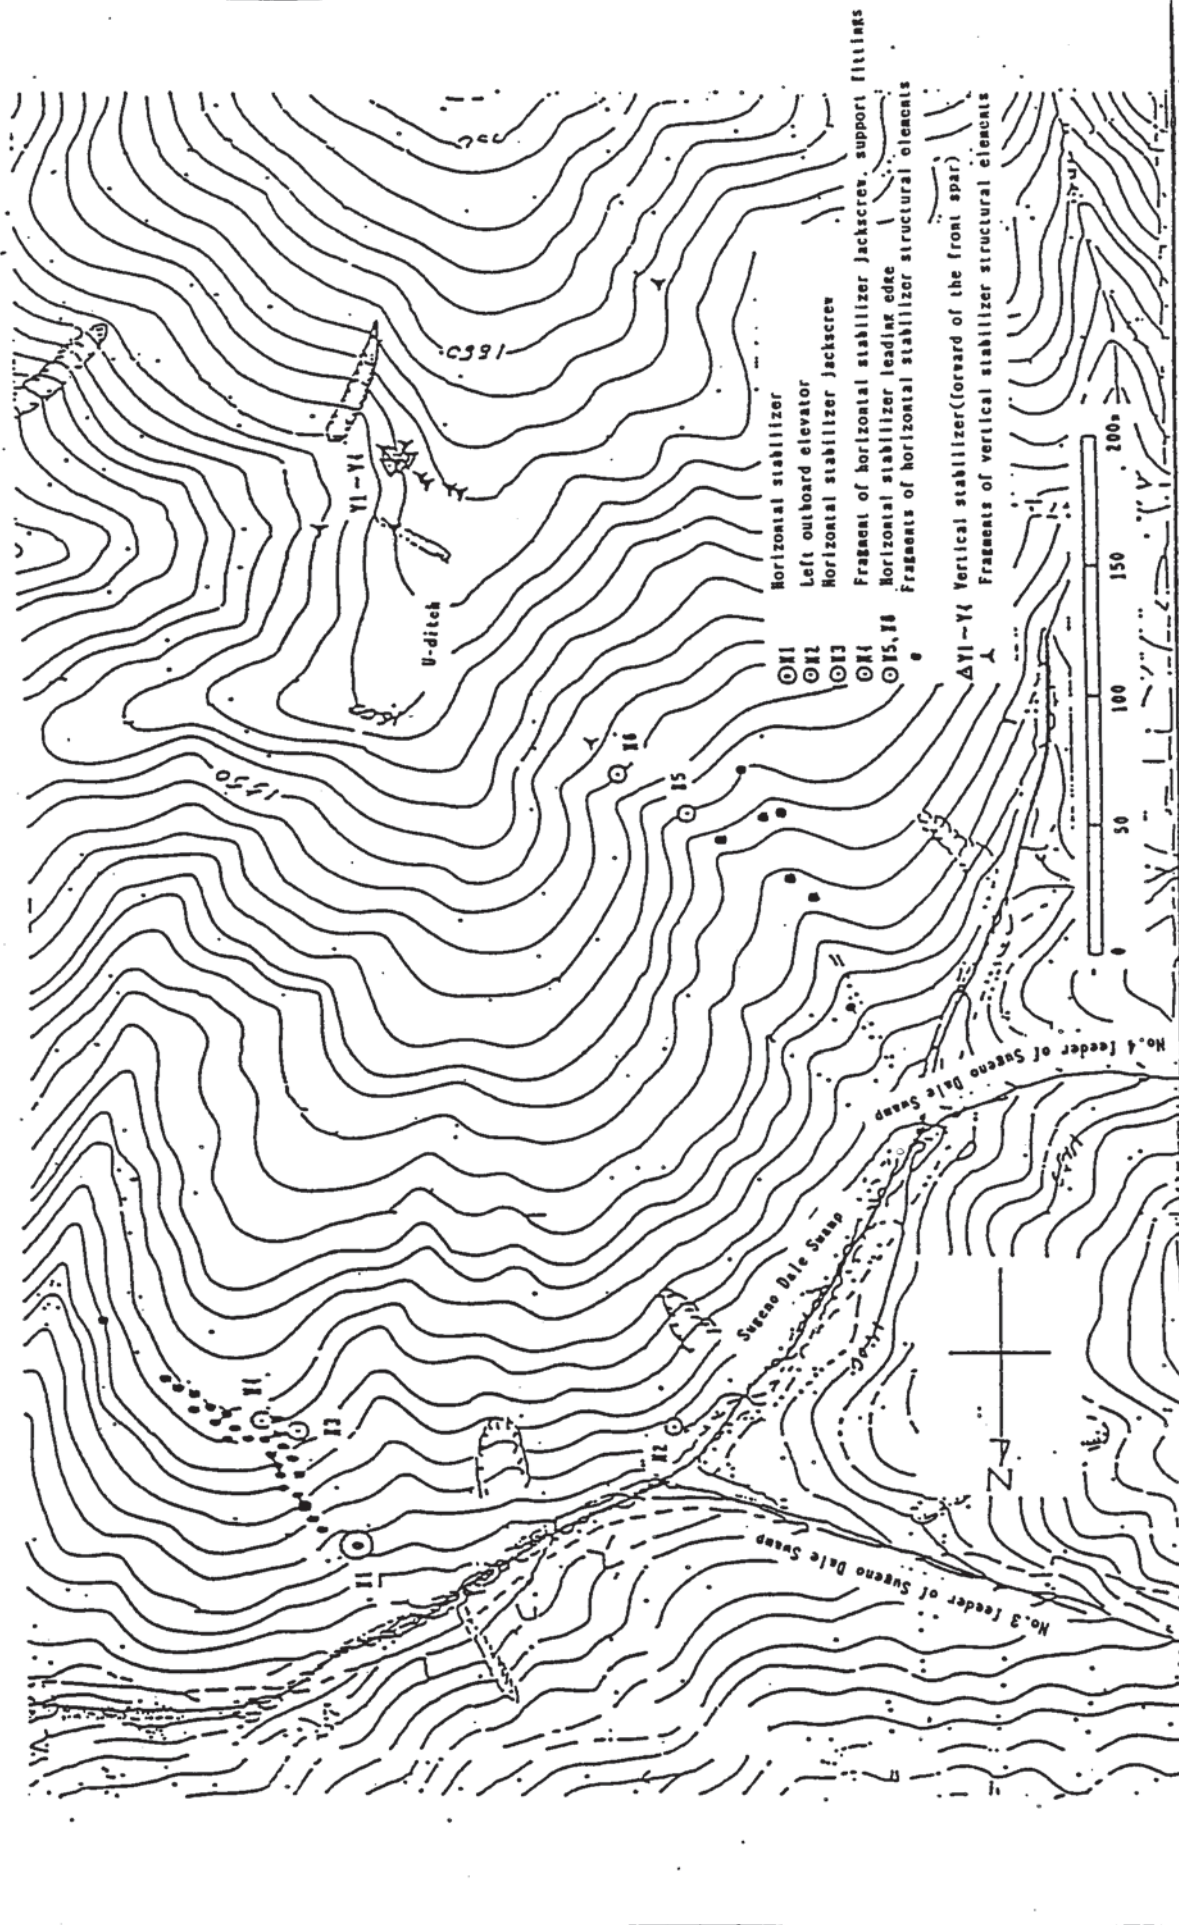
16 Distribution of wreckage — horizontal and vertical stabilizer

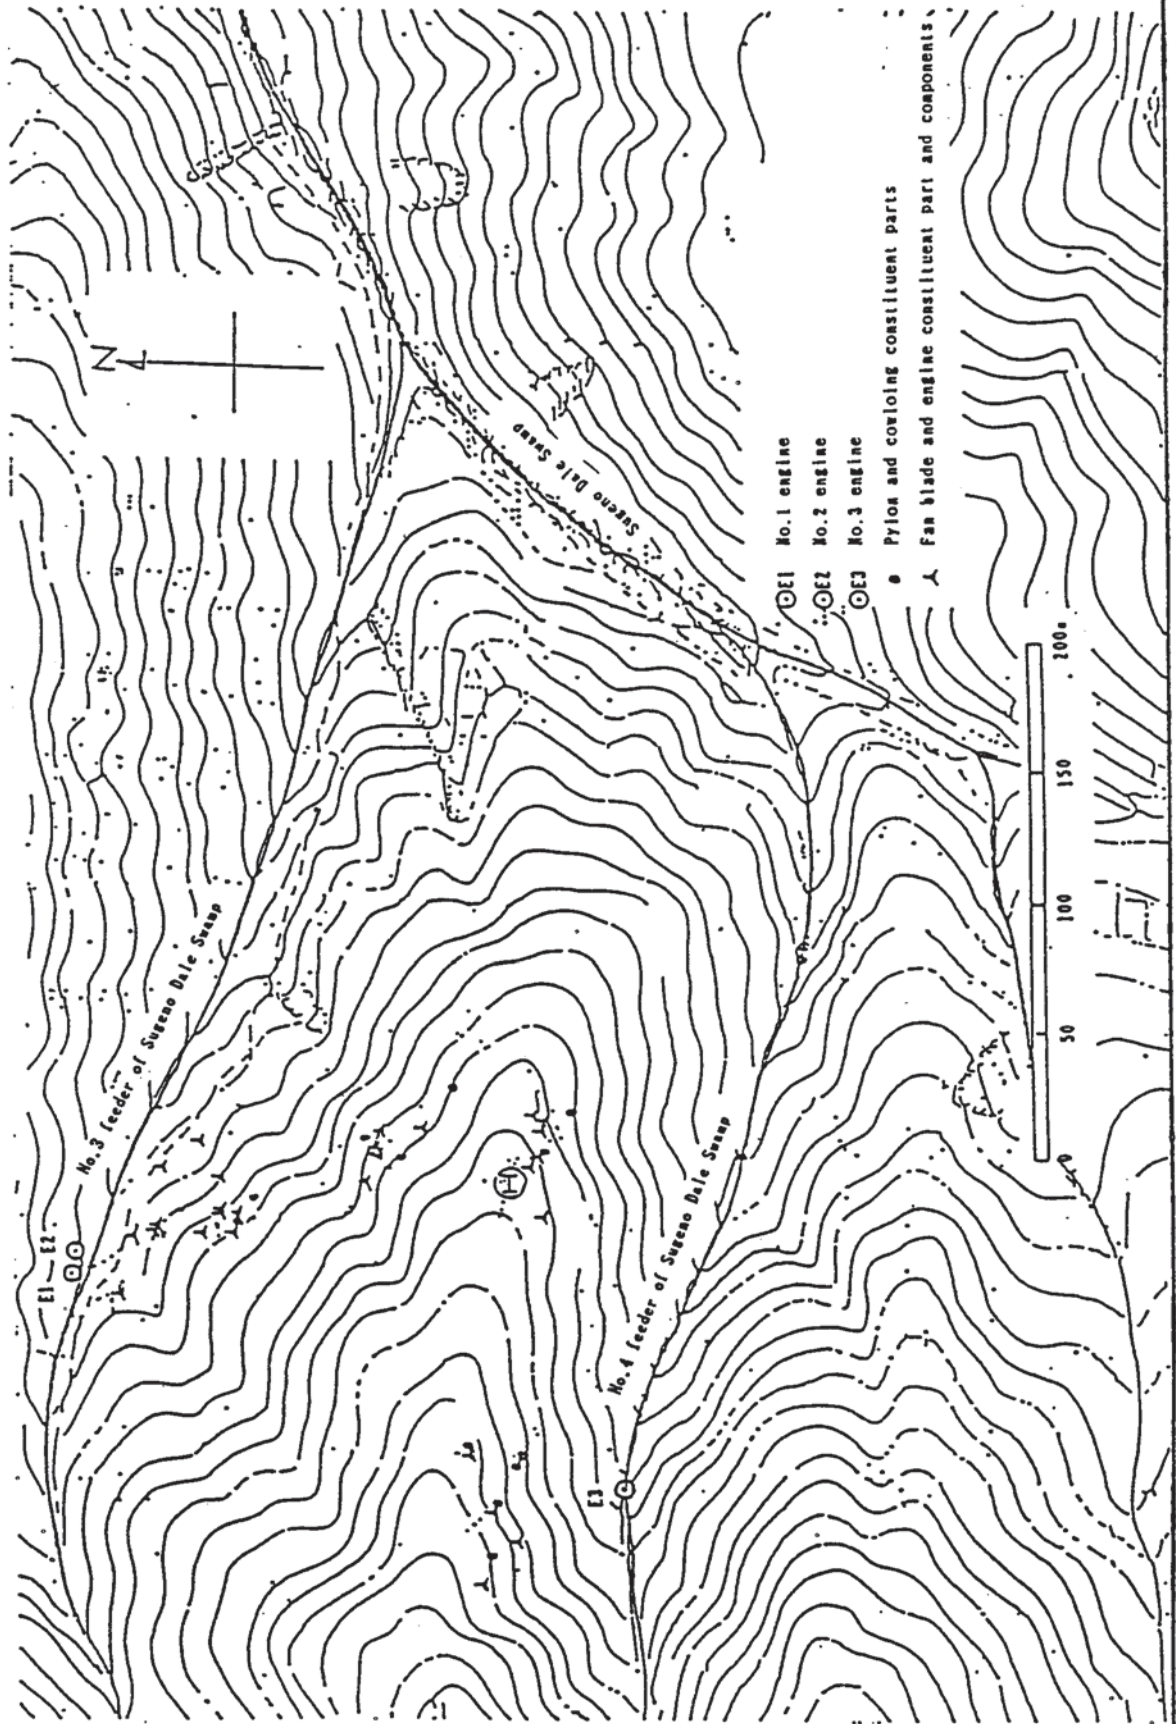
17 Distribution of wreckage - No. 1, 2, 3 engines

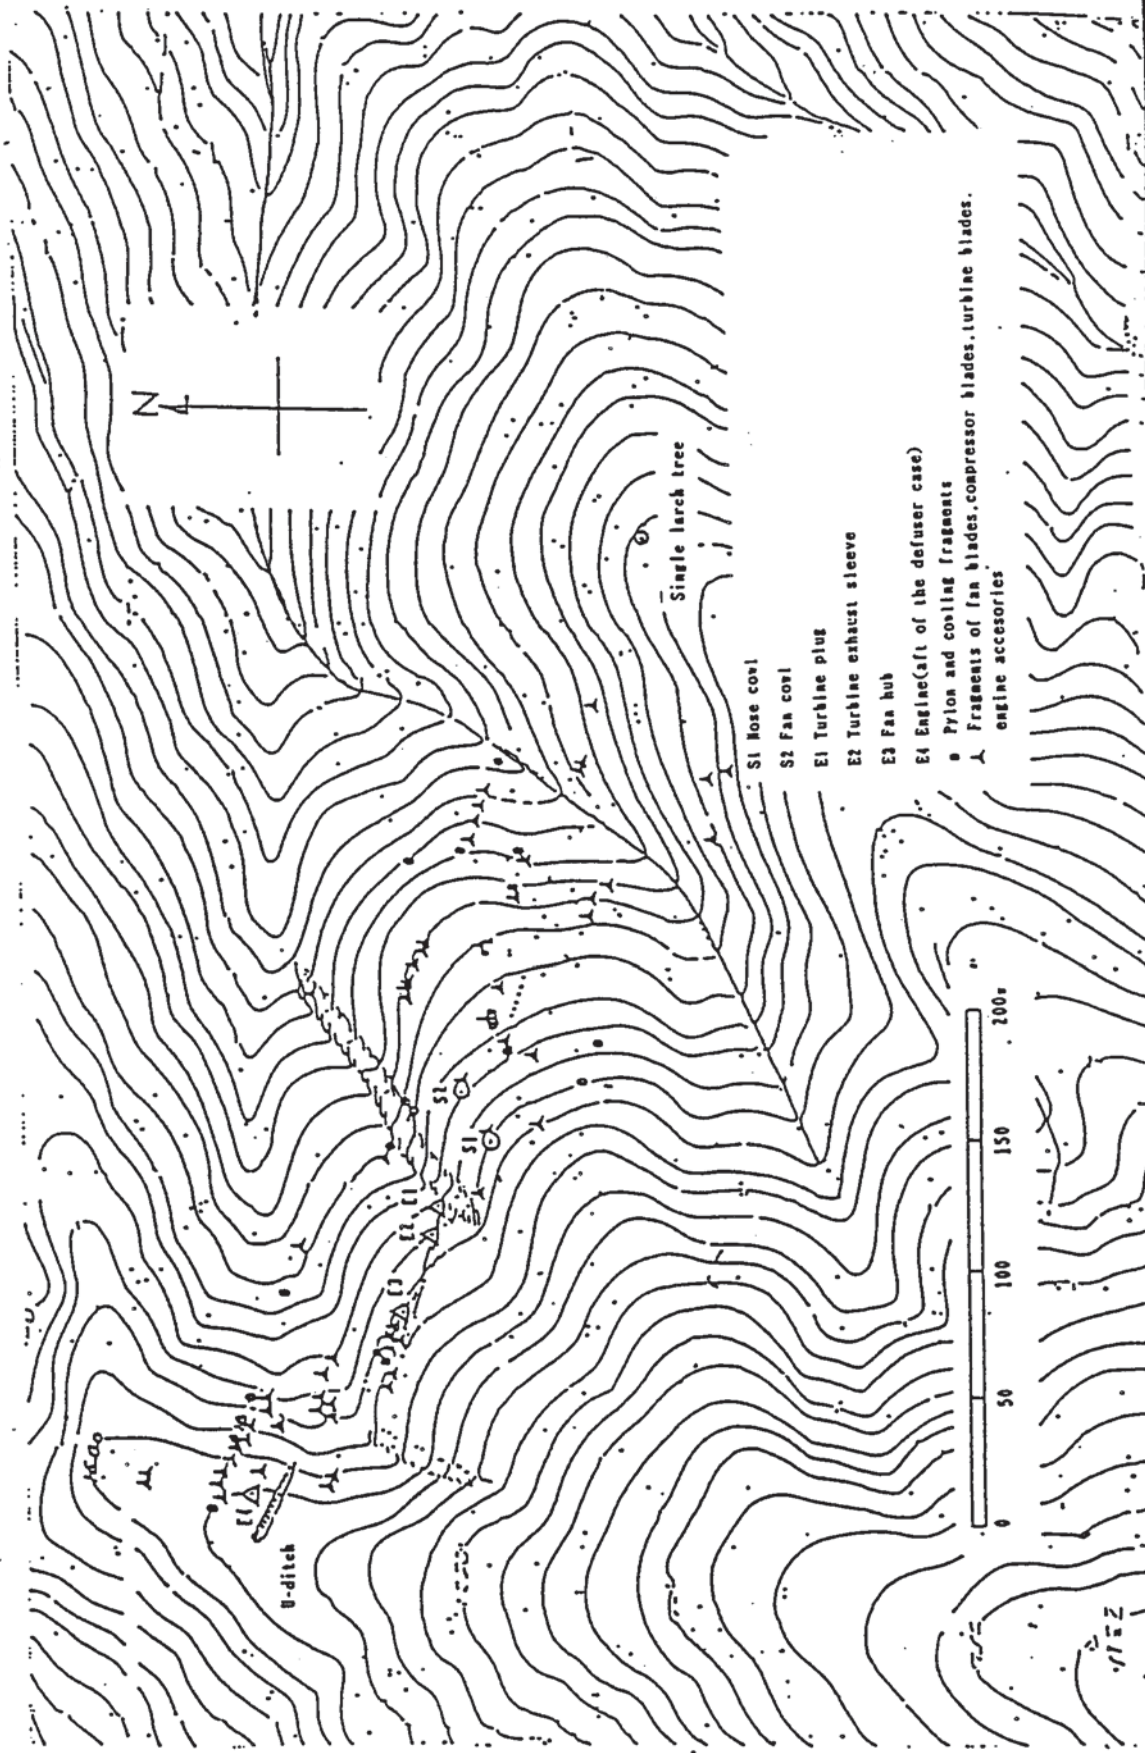
18 Distribution of wreckage — No.4 engine

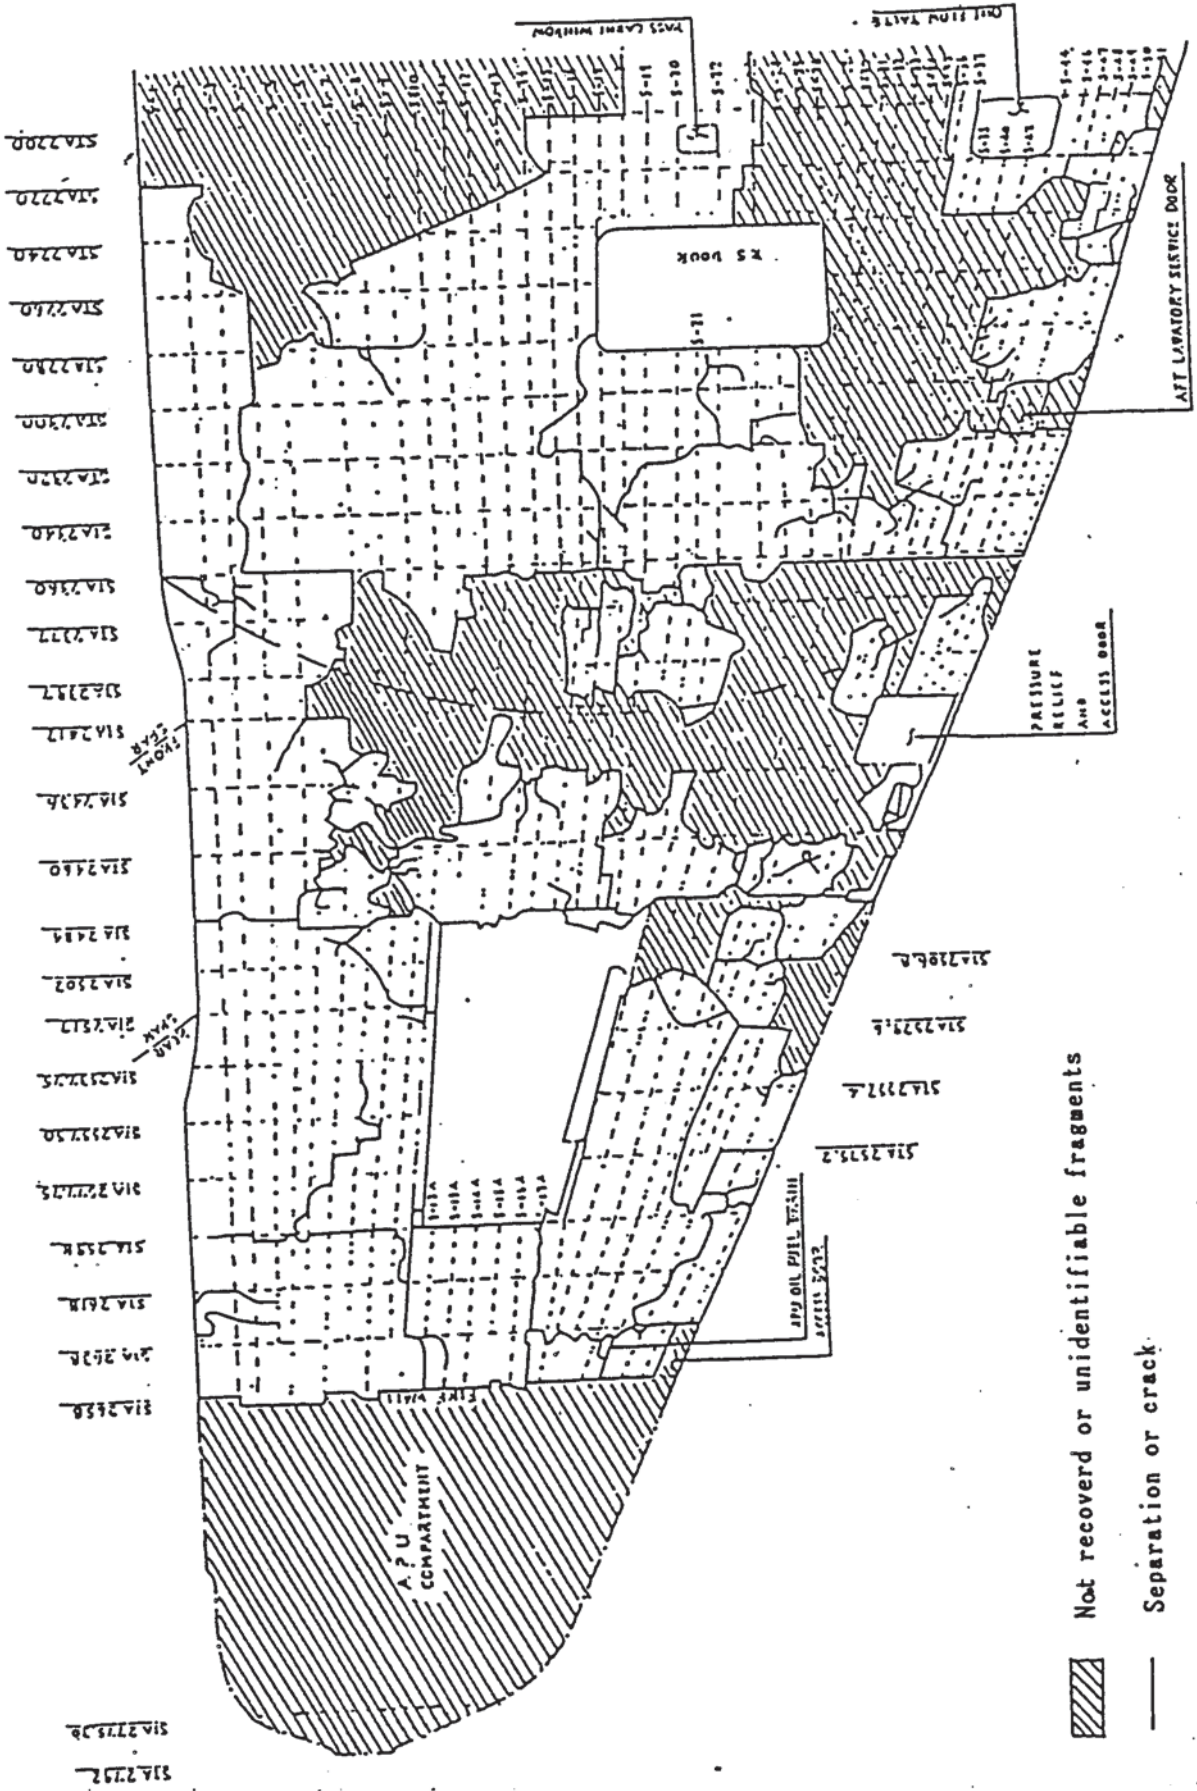
28 Damage to aft fuselage (right side)

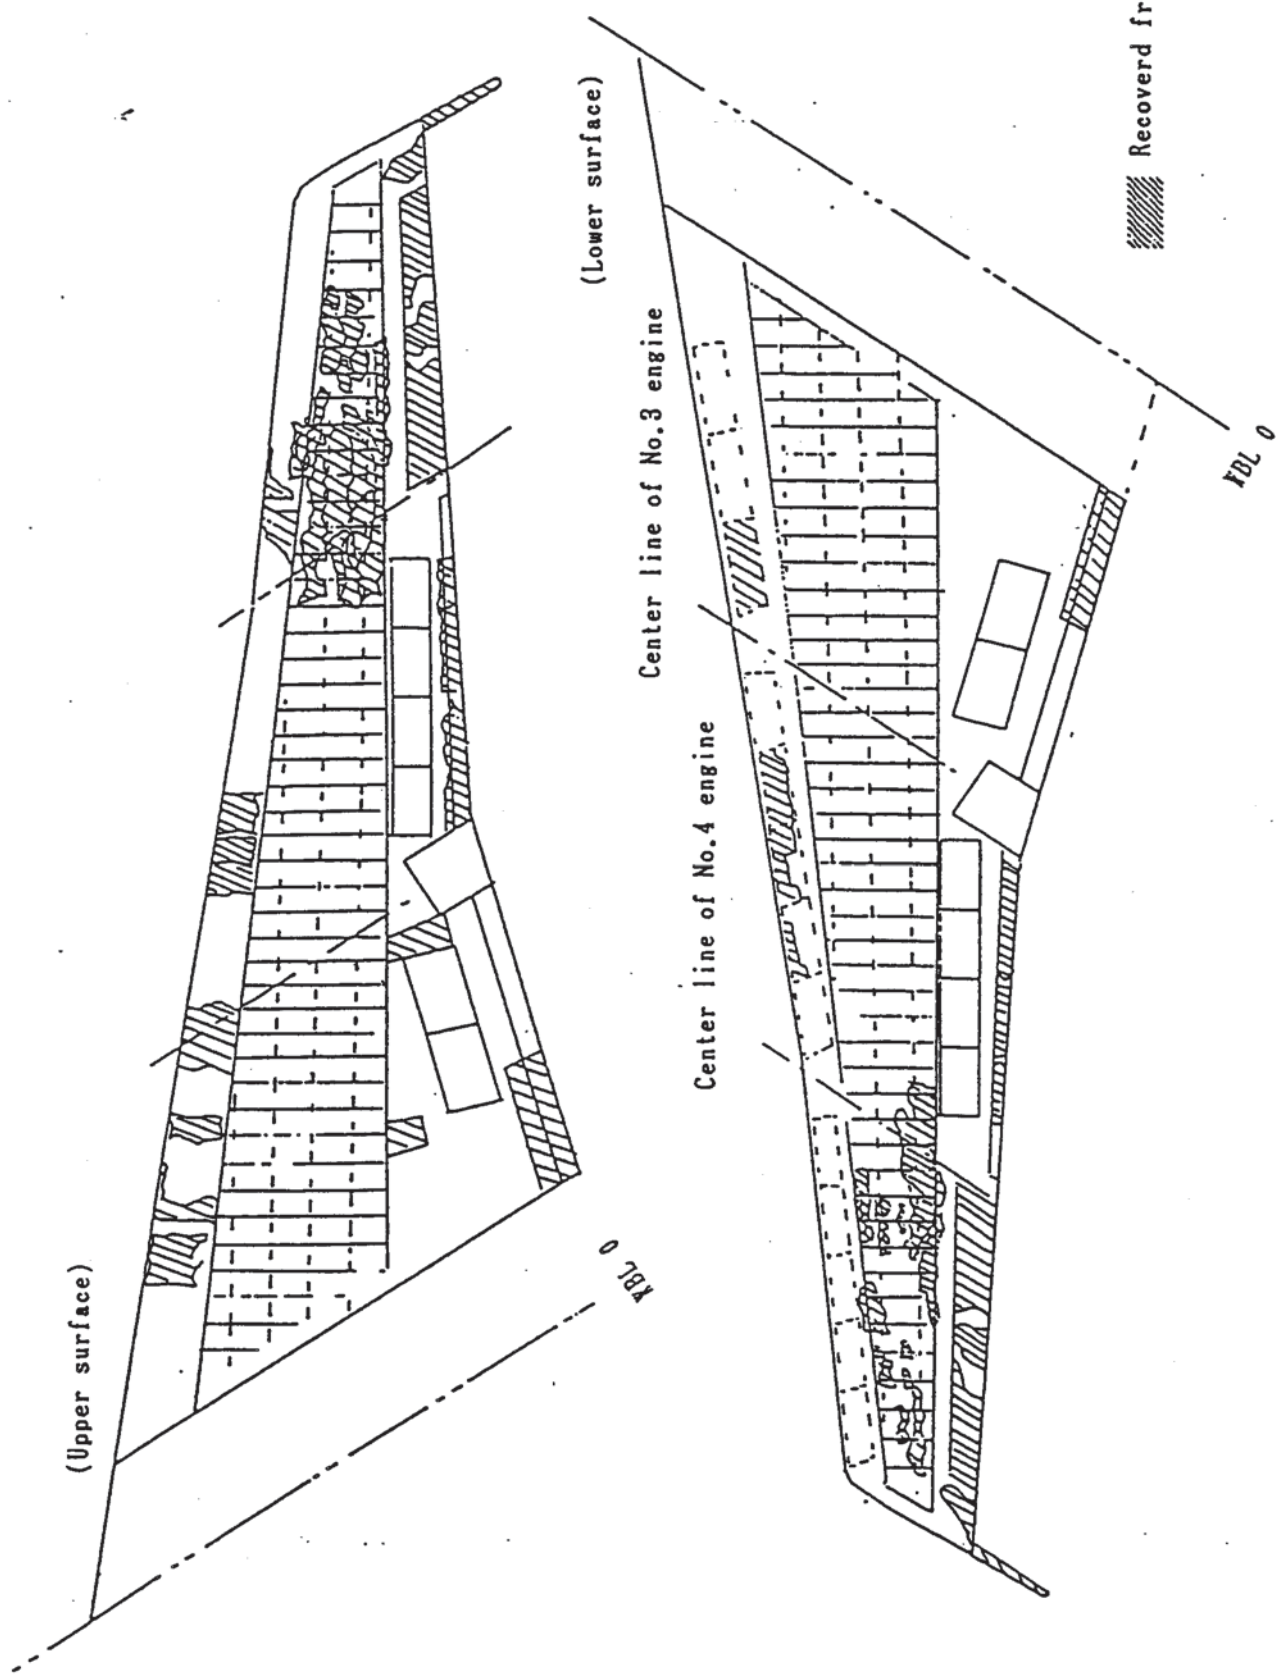
29 Right main wing recovered between single large tree and impact point

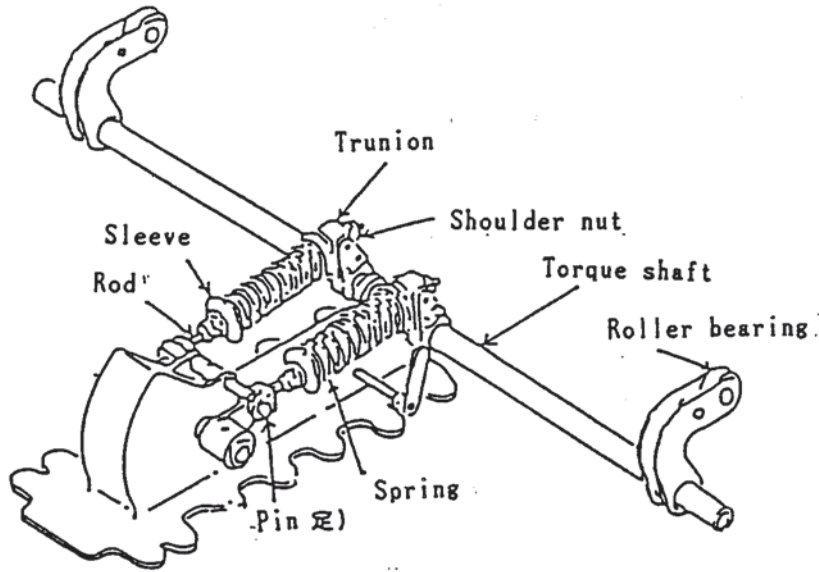
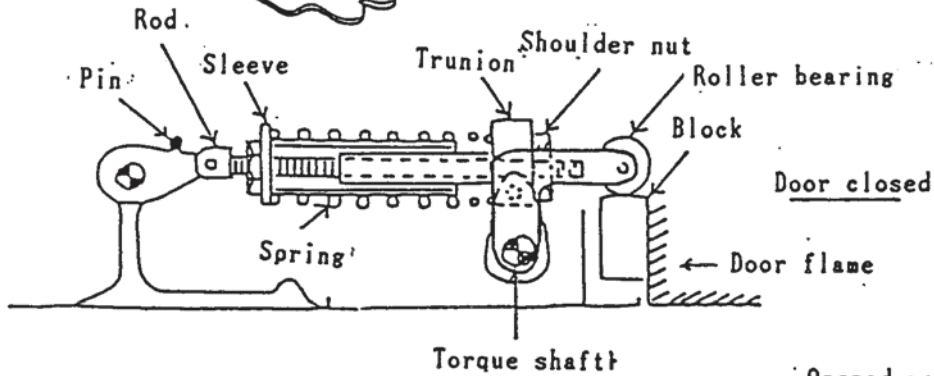
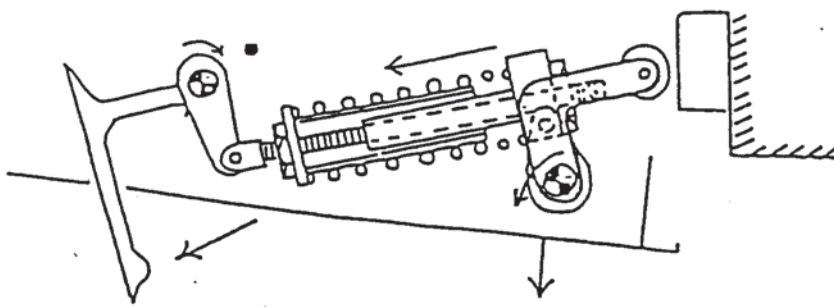
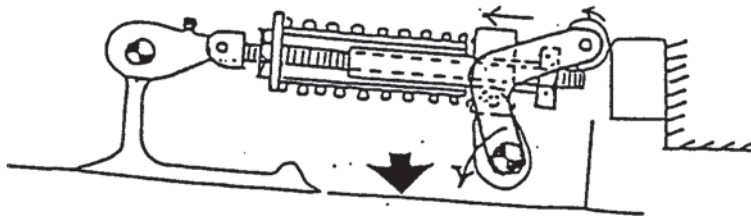
33 Latch mechanism of pressure relief door

Opened manually

Trunion don't slide on the Shoulder nut.

Opened without manually

Door will be opened without manually, the trunion slide on the shoulder nut against spring force

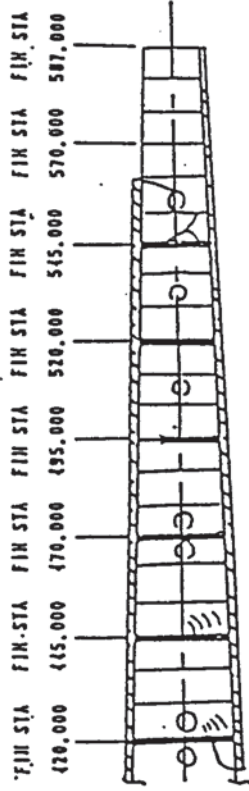
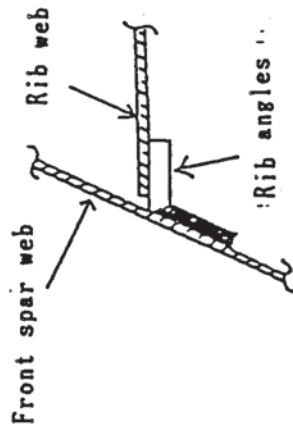
Typical fracture at corner of L section on the rib angle
